Pavement Distress Analysis on Pakuhaji Road Section, Tangerang Regency Using the Indeks Kondisi Perkerasan (IKP) Method

Muhammad Fawwaz Ferdiansyah¹, Reni Karno Kinasih¹

¹Civil Engineering Department, Faculty of Engineering, Universitas Mercu Buana, Jakarta, Indonesia

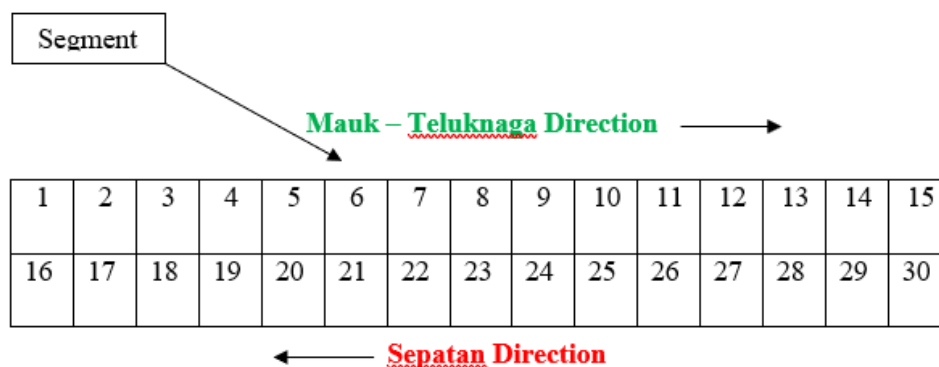
Figure 1. Segment Division Layout

- Length = 50 meters
- Width = 3.5 meters
- Area = 175 m^2

Therefore, the number of units for the 1500-meter road section was 30 units. The layout of segment division is presented in Figure 1.
